OVERVIEW MAIN TEST REPORTS ON ZINGA

GALVANIC PROTECTION

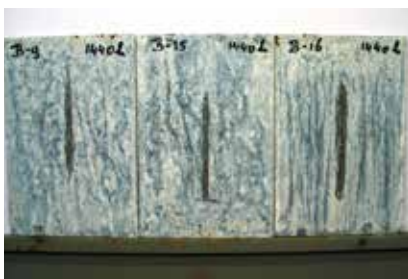
ZINGA 2 x 90 µm DFT after 720 h condensation (above) and 1440 h salt spray (under)

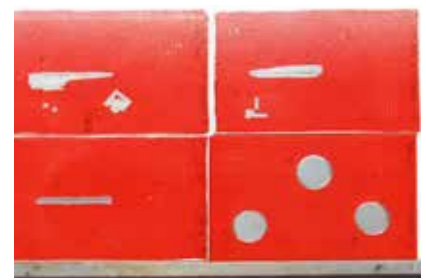
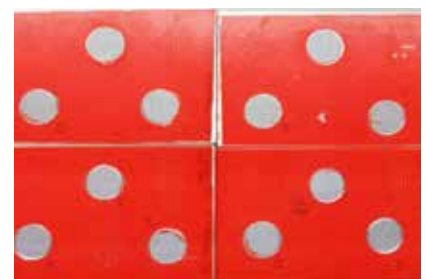
ZINGA + Zingaceram HS + Zingaceram PU after 720 h condensation (above) and 1440 h salt spray (under)

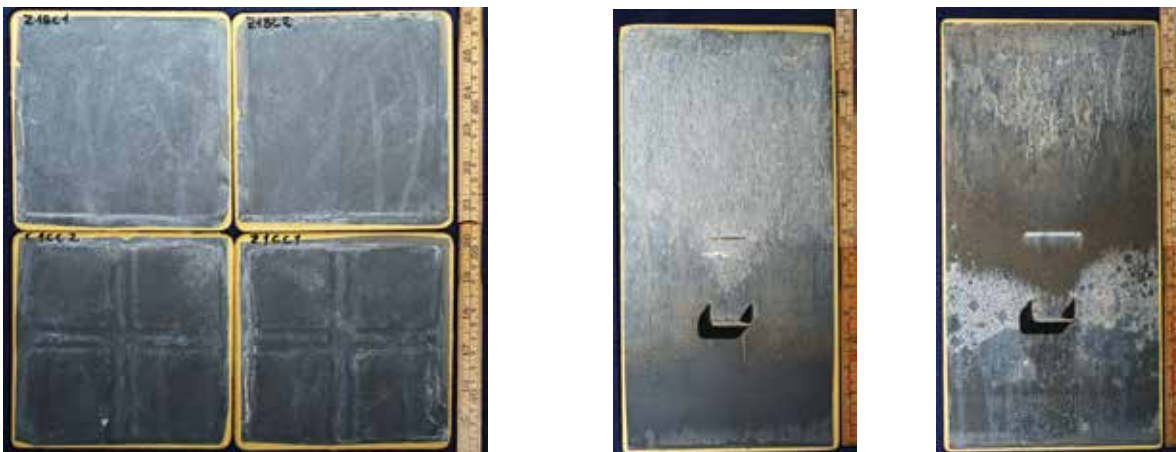
ZINGA 2 x 60 µm DFT after 180 days in a condensation chamber (left) or a wave tank (right)

ZINGA was applied on blast-cleaned test panels that were placed in a ballast tank filled with sea water with wave movement and cyclic heating. Other test panels were placed in a condensation chamber. No corrosion of the steel substrate could be demonstrated. Based on the results of the testing, ZINGA meets the requirements of a B3 classification - due to insufficient adhesion (but this poses no threat to ZINGA, whereas paints rely on this to perform). In the report is stated that ZINGA has a beneficial corrosion protective performance. For B1 classification, we refer to ZINGA BT.

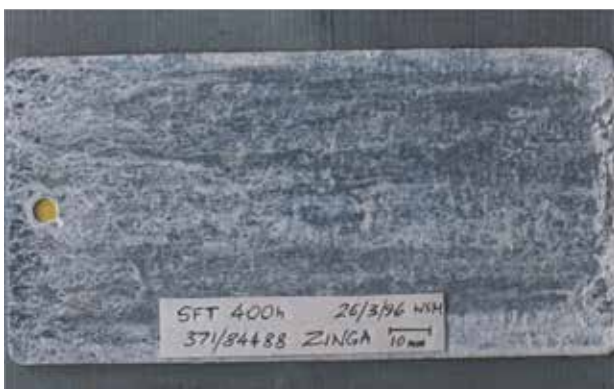
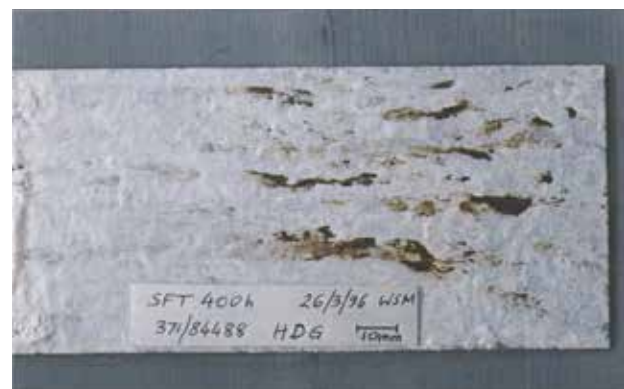
In this test it is demonstrated that the loss in weight of ZINGA is 1/10 of the loss in weight of hot-dip galvanising after a 400 hours salt spray test. The layer thickness of ZINGA diminishes because ZINGA is being consumed, contrary to a paint that will start to peel off after a certain period of time. This illustrates the fundamental difference between a paint and a galvanising system.

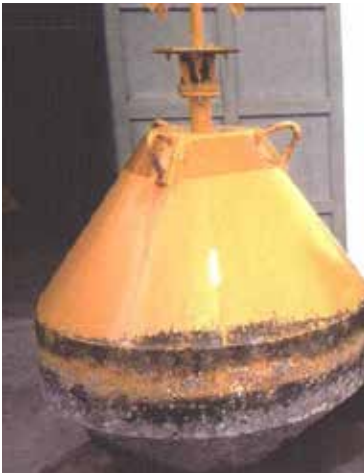
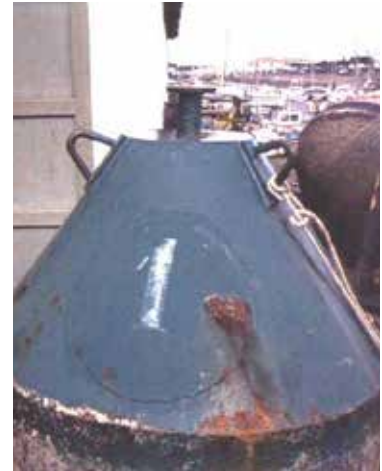
Two buoys (one treated with ZINGA, the other one hot-dip galvanised) have floated in the Atlantic Ocean for four years. After those four years, the buoy treated with ZINGA showed no trace of rust while the hot-dip galvanised buoy was severely corroded in several places.

Left: Buoy treated with ZINGA + topcoat

Right: Buoy treated with HDG + topcoat

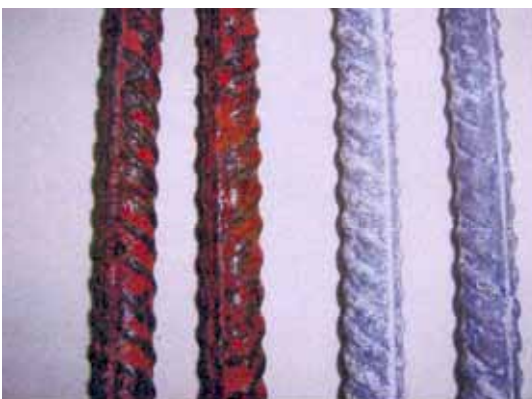
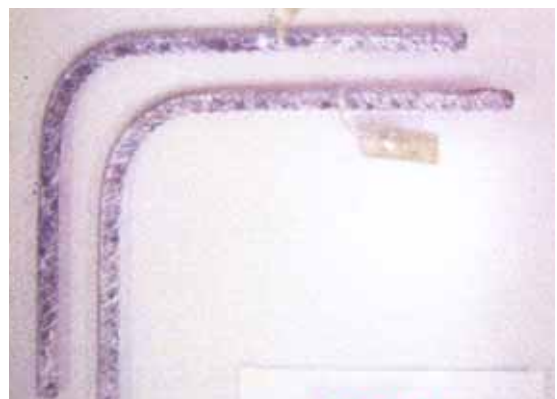
The zinganised rebars passed the 500 hours salt spray test without formation of rust, peeling or blistering, not even in places where the coating was mechanically damaged. The rebars that were not zinganised were heavily corroded.

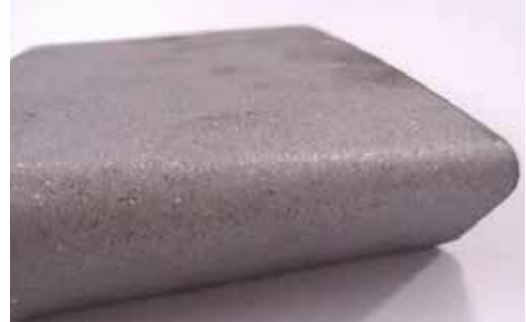
ZINGA showed no cracks when bending on a cylindrical mandrel with a diameter of 12 mm.

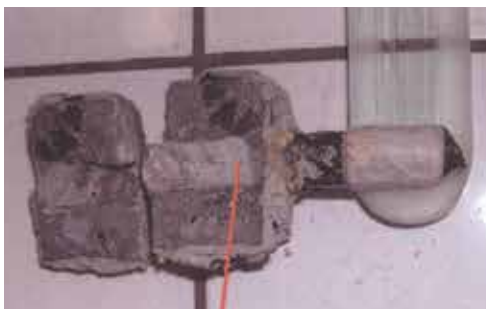
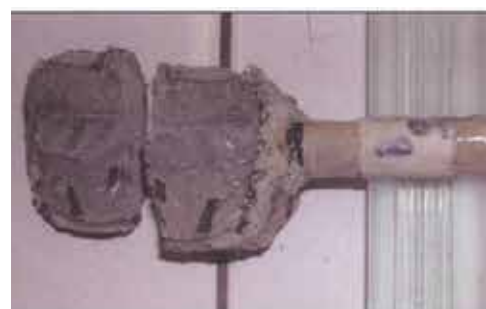
It is clearly more difficult to cleave the rebar bloc containing the steel rod protected with ZINGA. The adherence of the concrete to the Zinganised rod is better. The actual cleavage happens in the concrete (in contrast to the other two rebars, which cleaved neatly between steel and concrete), which indicates a strong adherence.

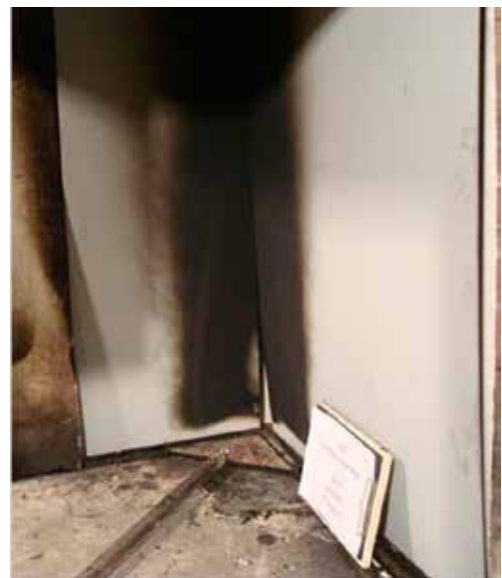
ZINGA 2 x 90 µm DFT Reaction to fire classification: **B - s1, d0**

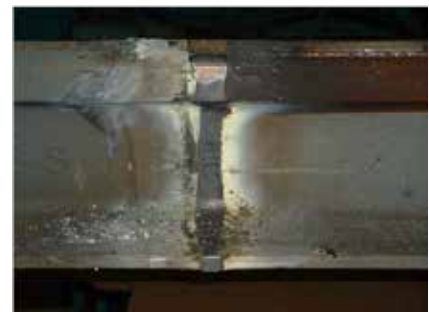
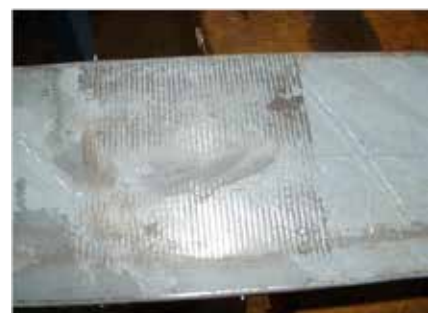
The four foot length was subsequently bend tested and despite the apparent slippage broke at 1430 kN. This comfortably passed the Network Rail specification minimum of 1220 kN. The grab marks induced by the compressional strength of 1.5 tons, required to hold the rail-track ends together during the welding operation illustrate how ZINGA was crushed into the metal during this phase.
